**DEPARTMENT OF TRANSPORTATION****DIVISION OF ENGINEERING SERVICES**

Quality Assurance and Source Inspection

Contract #: 04-0120F4Cty: SF/ALA Rte: 80 PM: 13.2/13.9File #: 69.28**WELDING INSPECTION REPORT****Resident Engineer:**Siegenthaler, Peter**Address:** 333 Burma Road**City:** Oakland, CA 94607**Report No:** WIR-020653**Date Inspected:** 15-Feb-2011**Project Name:** SAS Superstructure**OSM Arrival Time:** 700**Prime Contractor:** American Bridge/Fluor Enterprises, a JV**OSM Departure Time:** 1900**Contractor:** Zhenhua Port Machinery Company, Ltd (ZPMC), Changxing Island **Location:** Shanghai, China**CWI Name:** Qiu Wen.**CWI Present:** Yes No**Inspected CWI report:** Yes No N/A**Rod Oven in Use:** Yes No N/A**Electrode to specification:** Yes No N/A**Weld Procedures Followed:** Yes No N/A**Qualified Welders:** Yes No N/A**Verified Joint Fit-up:** Yes No N/A**Approved Drawings:** Yes No N/A**Approved WPS:** Yes No N/A**Delayed / Cancelled:** Yes No N/A**Bridge No:** 34-0006**Component:** OBG components.**Summary of Items Observed:**

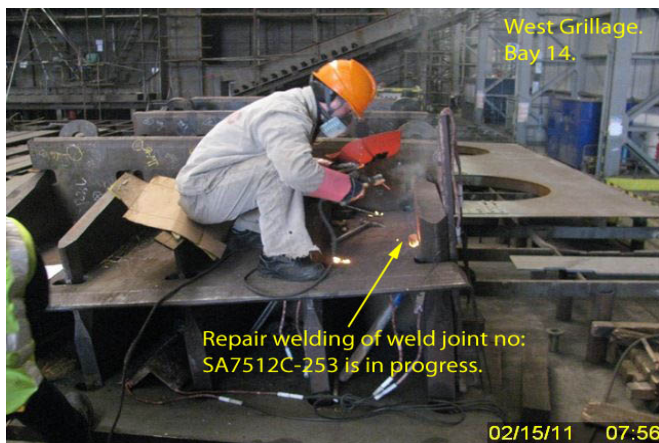
Repair welding of weld joint no: SA7512C-253, complete joint penetration (CJP) weld. The welder is identified as 066398 and was observed welding in the 1G position. Welding process was identified as Shielded Metal Arc Welding (SMAW). ABF QA was identified as Ji Cai Feng. The welding variables appeared to comply with Welding procedure specification (WPS): 345-SMAW-1G(1F)-FCM-Repair-1. Repair welding was done as per Critical Welding Repair (CWR) Report: B-CWR 2629 Rev-3. See attached photo for details.
